Limited Visual Dam Safety Inspection Summary Report

MA-080

Reservoir 60

May 2006

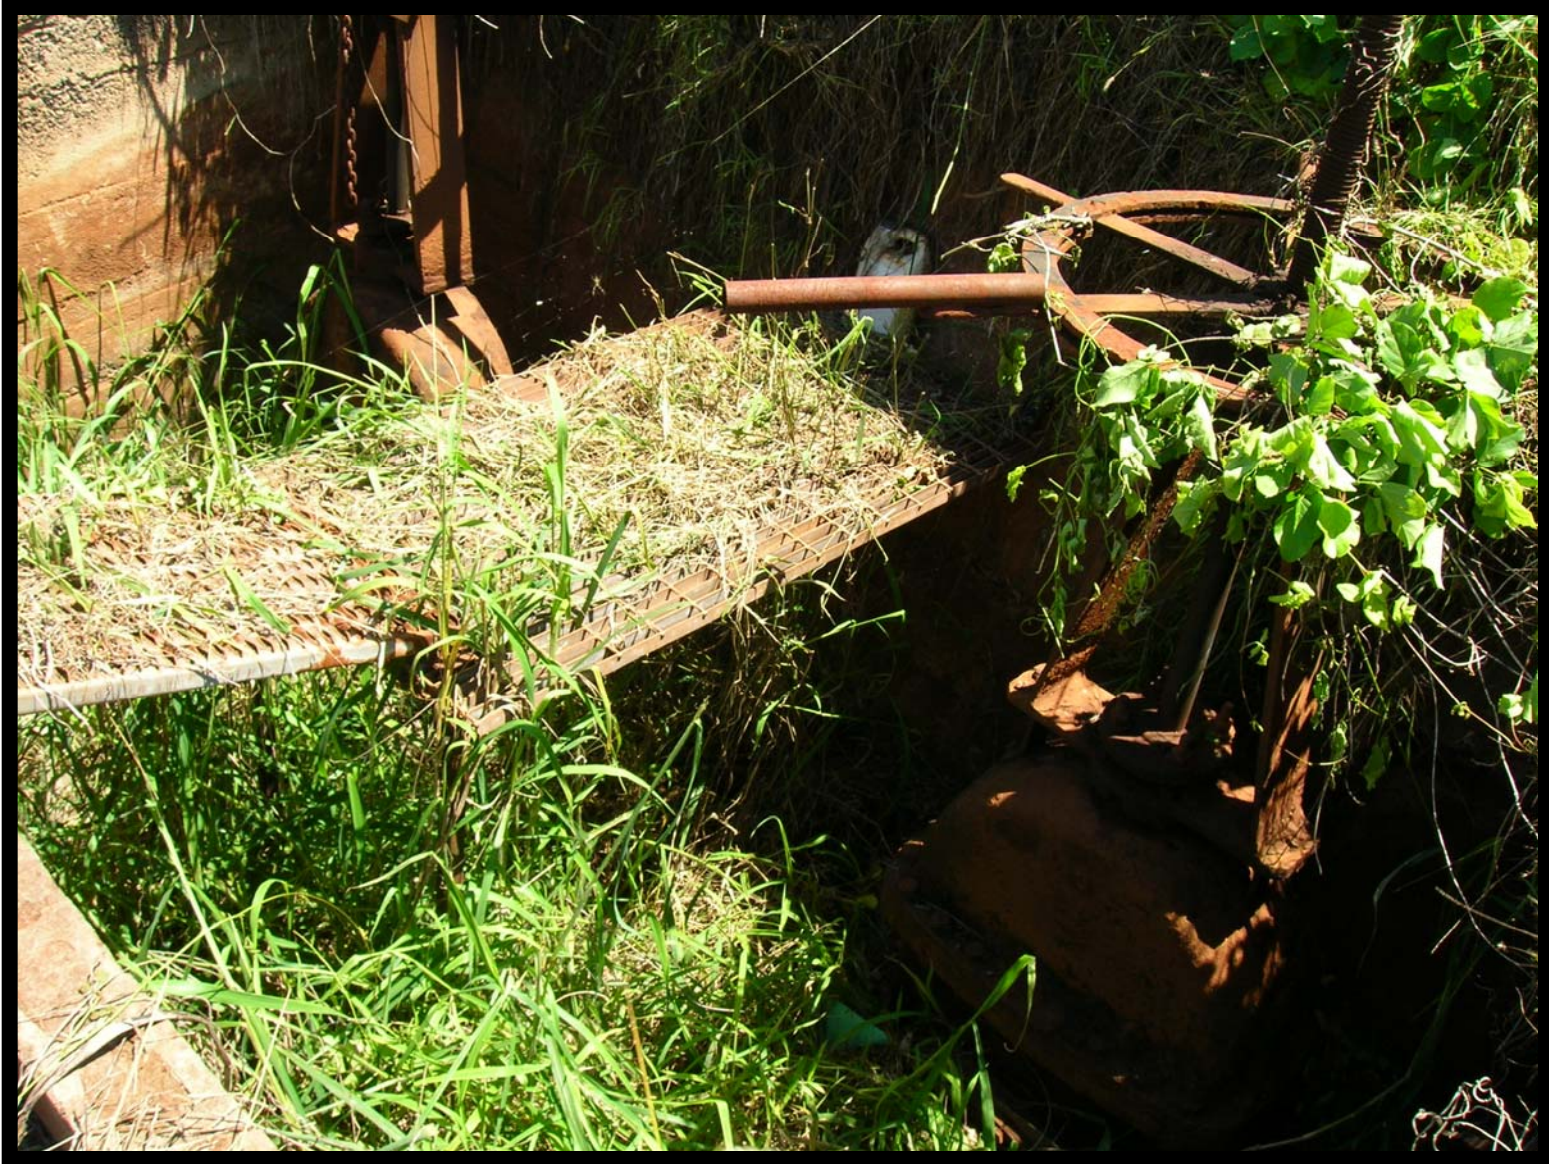
080 outlet 2

There was headcut erosion observed at the outlet exit.

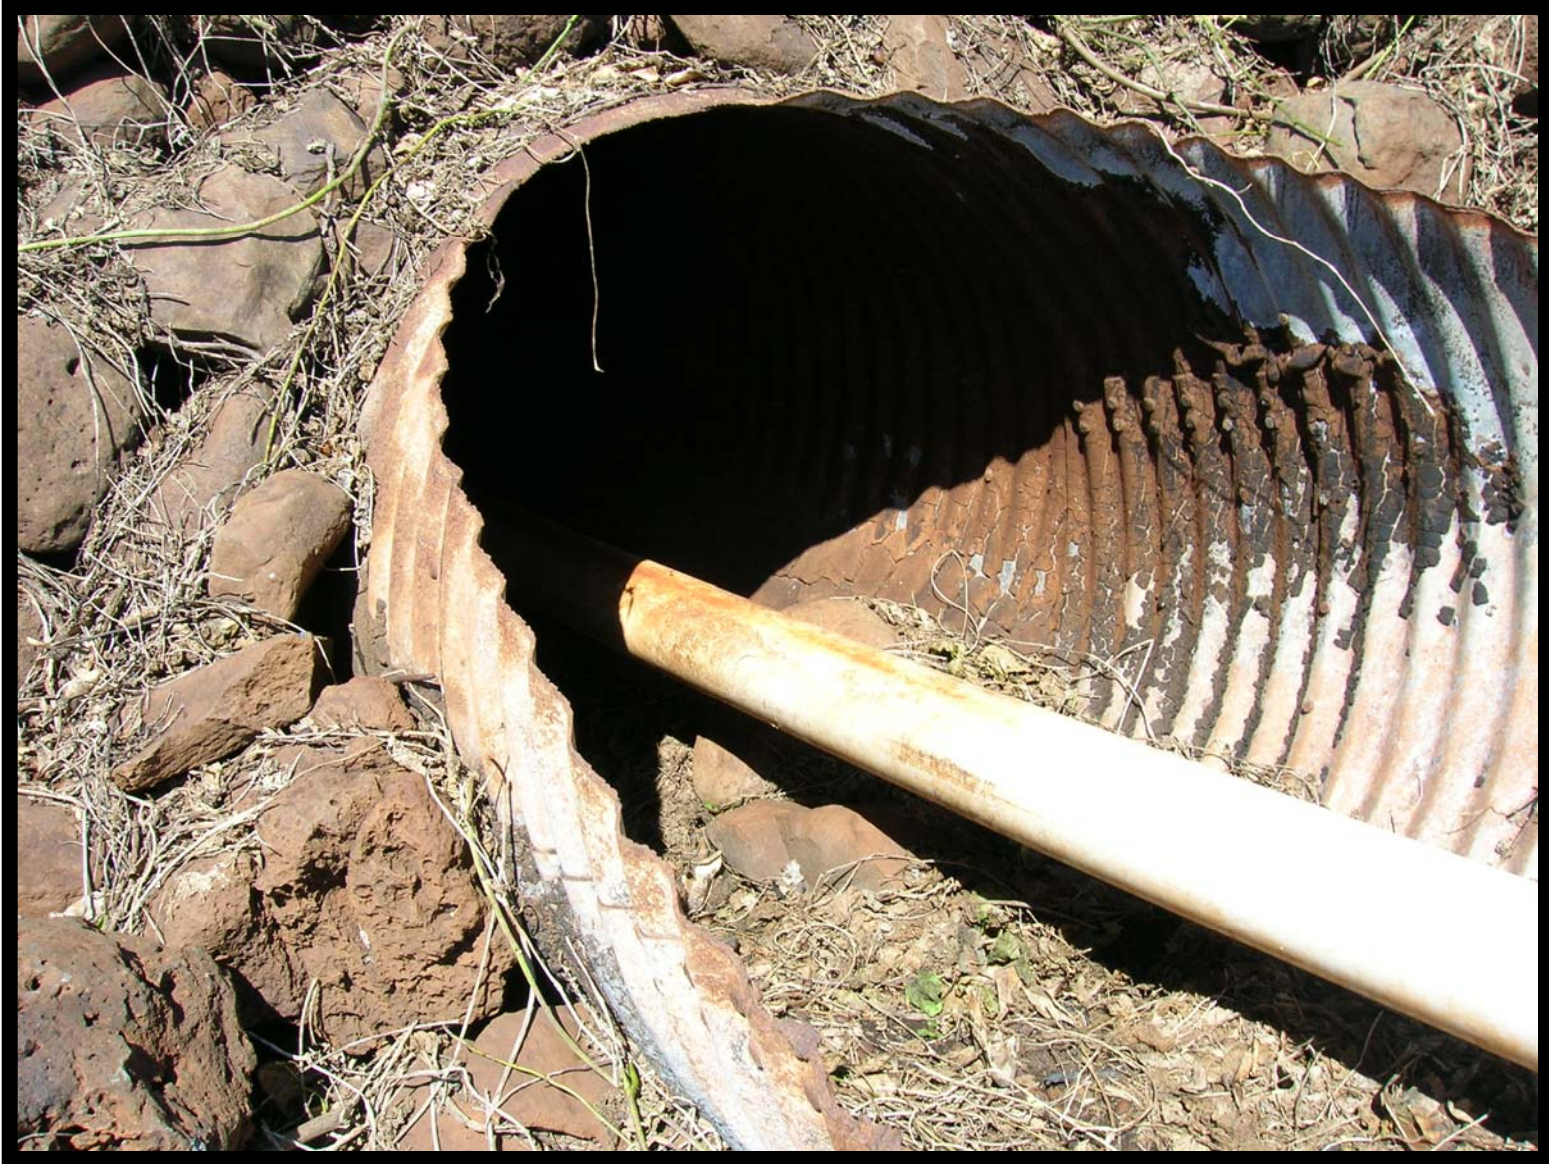
080 spillway 2

- a. The Spillway appeared to be in fair to poor condition and requires corrective action.
- b. Unclear if spillway is adequately sized. Spillway should pass the probable maximum flood. Verify spillway capacity and take corrective action as required.
